**EURO – Zel 2010**

18th International Symposium

# Assessment of Technical State and Method of Repair of Three-span Viaduct over Railway Line

**ARKADIUSZ GRZEGORZ MORDAK**

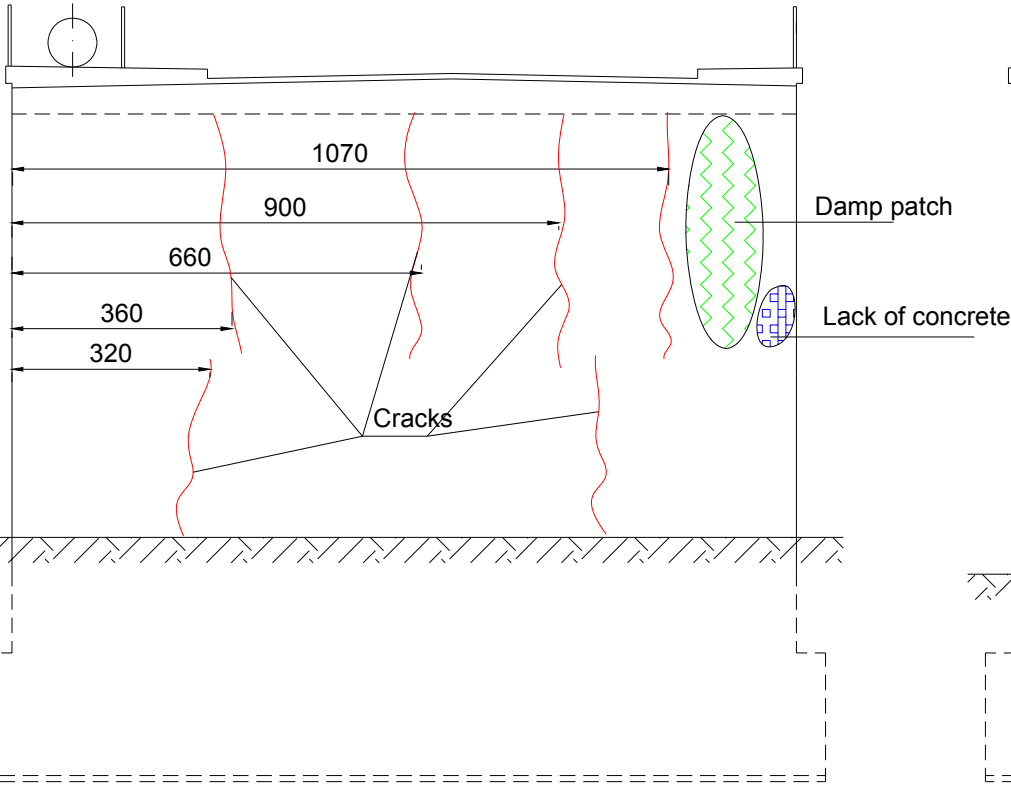
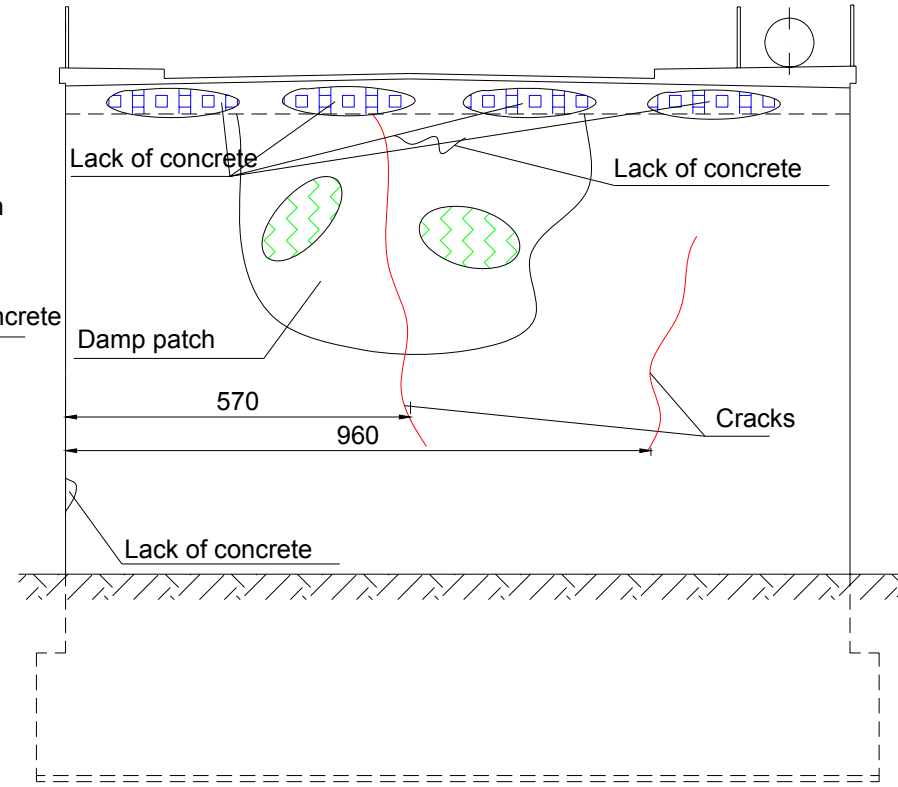
- ❑ 6 cracks thickness less than 1.0–1.5 mm on the left abutment (from the cement mil side). Four of them run across the whole pier height (from bridge deck plate to foundation), what can provide unequal settlement of the pier 6,
- ❑ two cracks, thickness less than 1.0 mm on the right abutment (from the lime stone mine side). One of them run across the whole pier height and additional visible damp patches and vegetation of moss ,
- ❑ visible reinforcement lagging lacks, concrete corrosion of both abutments (decorticates), and corrosion of reinforcing steel bars too 7.

**View on the road viaduct abutment head damages:**

**a) from the cement mill side, b) from the lime stone mine side**

- verify the propagation of the cracks by glass seals gluing 5,
- if the cracks were stabilized it was necessary to inject the cracks by injecting emulsion and complete uncovered reinforcement lagging lacks by suitable PCC mortars,

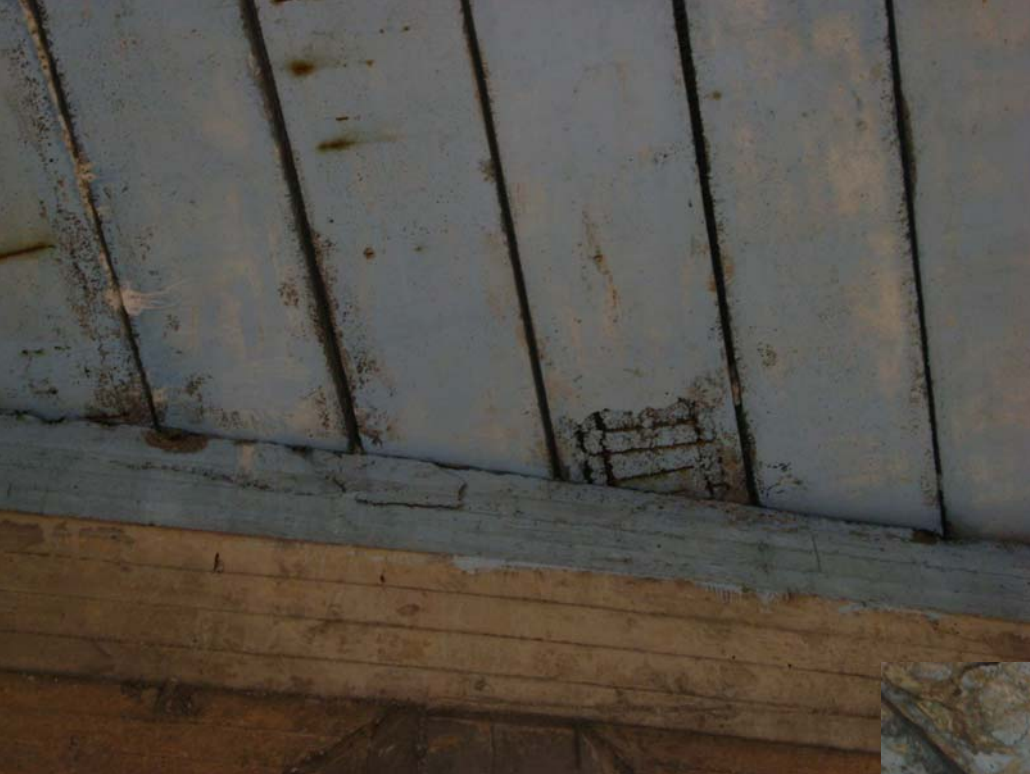
- ❑ a lot of reinforcement lagging lacks of reinforced Gromnik type concrete girders - it was the reason of progressive concrete girders steel reinforcing bars corrosion 1,
- ❑ a lot of damp patches, blooms and icicles from the bottom side of the spans. It provides that insulation of the bridge deck was not tight and non-effectiveness of drainage system 2,
- ❑ concrete corrosion in some main girders (decorticates) 3,

**Bottom view on damages and reinforcement lagging lacks of main girders and piers cap**

- ~~clean~~ and anti-corrosion protect uncovered reinforcing bars,
- complete the reinforcement lagging lacks of reinforcement,
- rebuild of piers cap,
- exchange of expansion joints,
- clean the concrete surfaces from blooms and damp patches,
- clean, complete and execute of cover layers on concrete elements.

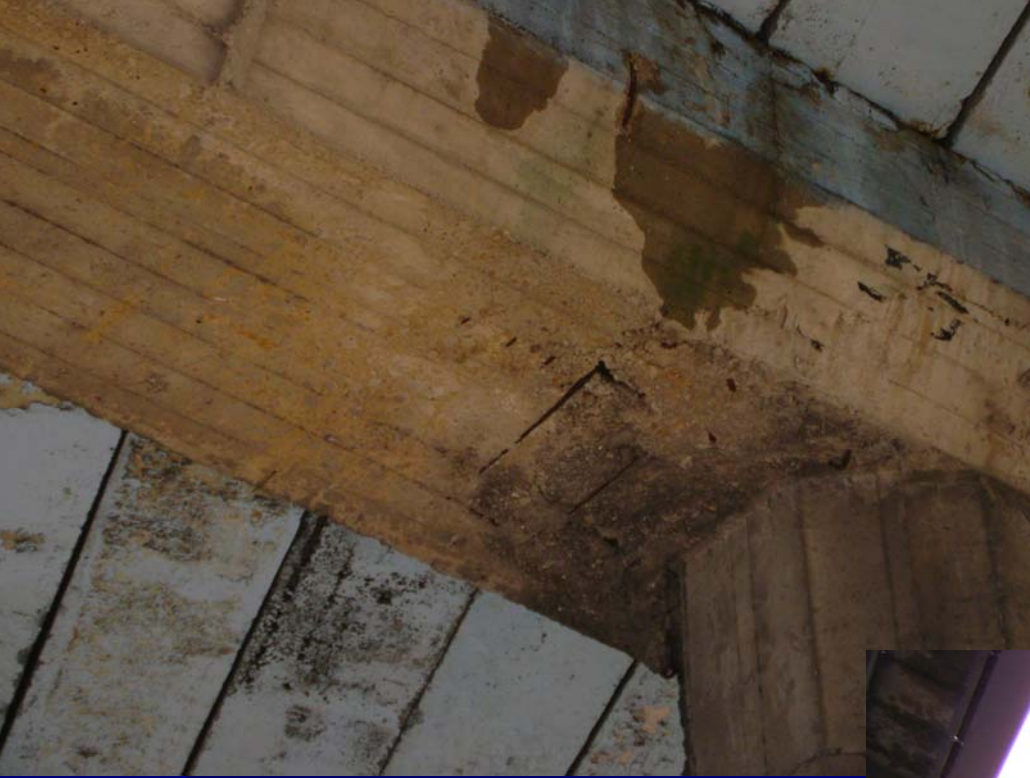
**Bottom span view.  
Visible damages of main  
girders and piers cap  
(concrete corrosion,  
decorticates, damp  
patches).**

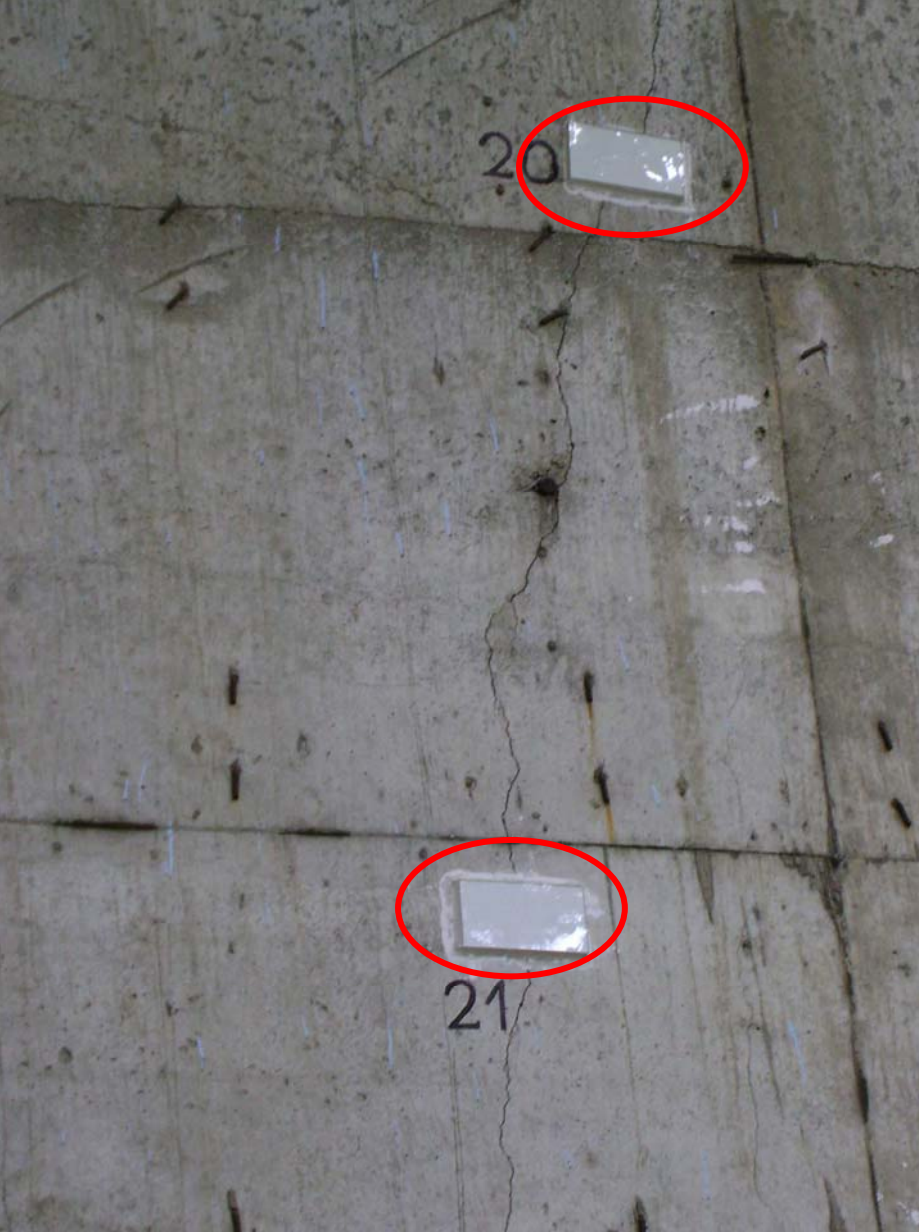
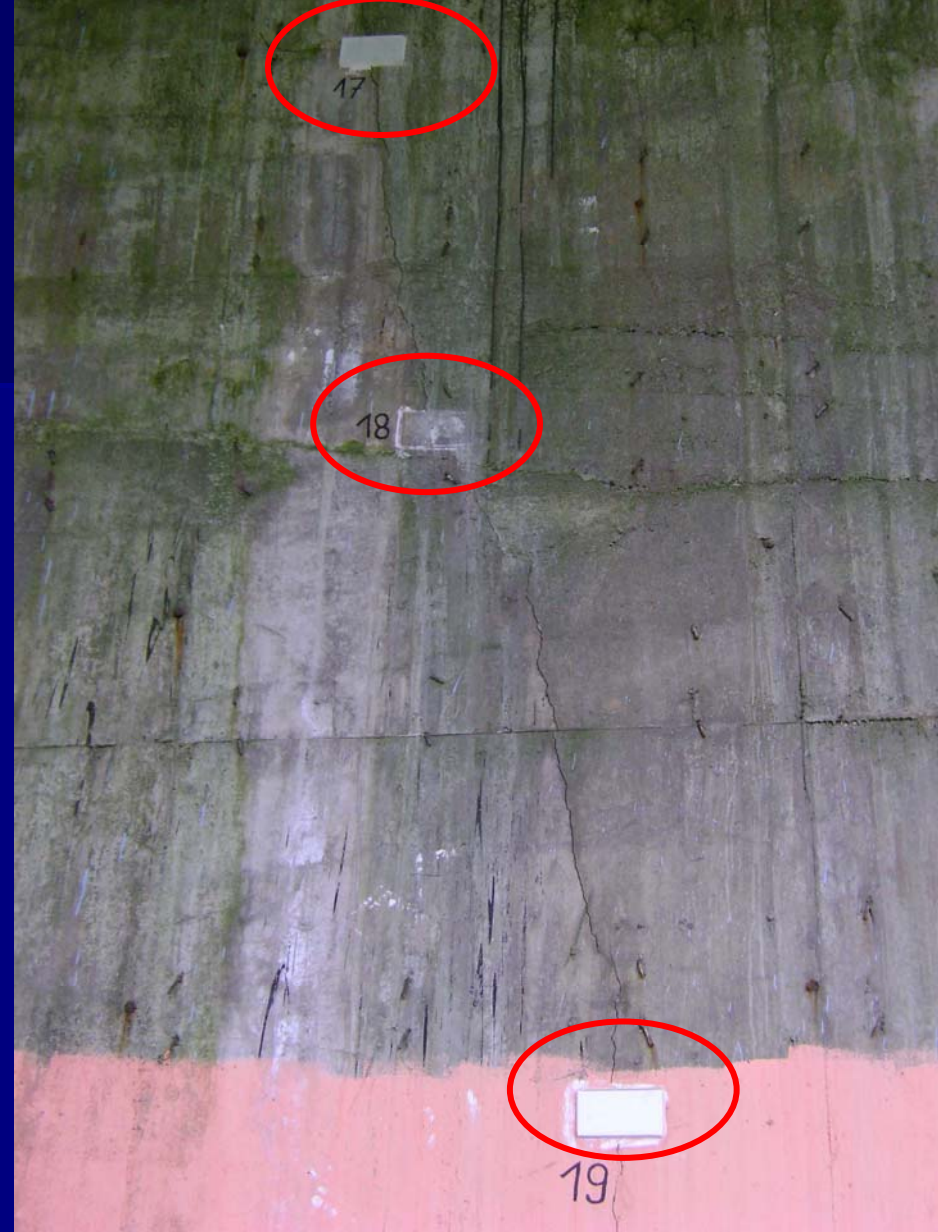
**View on the glass seals glued to the cracked surface of the abutments**
