**EURO – Zel 2010**

18th International Symposium

# Assessment of Technical State and Method of Repair of Three-span Viaduct over Railway Line

**ARKADIUSZ GRZEGORZ MORDAK**

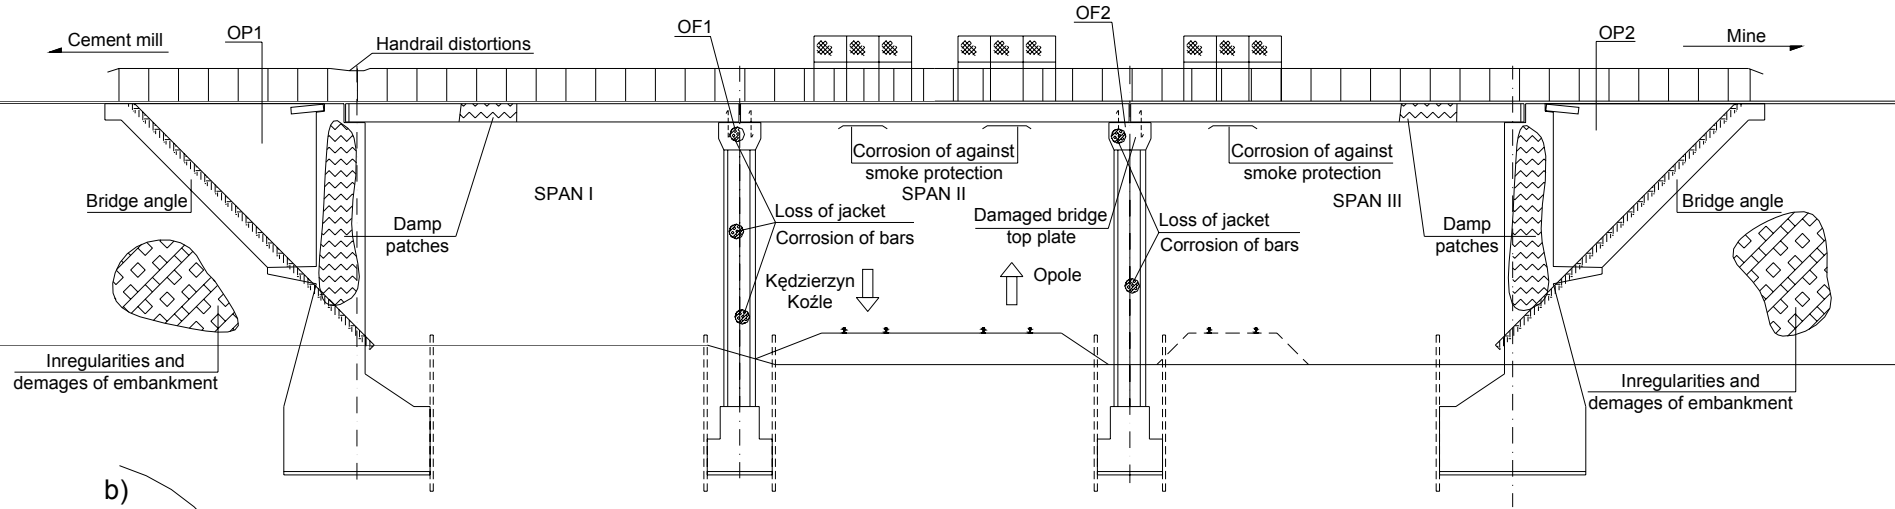
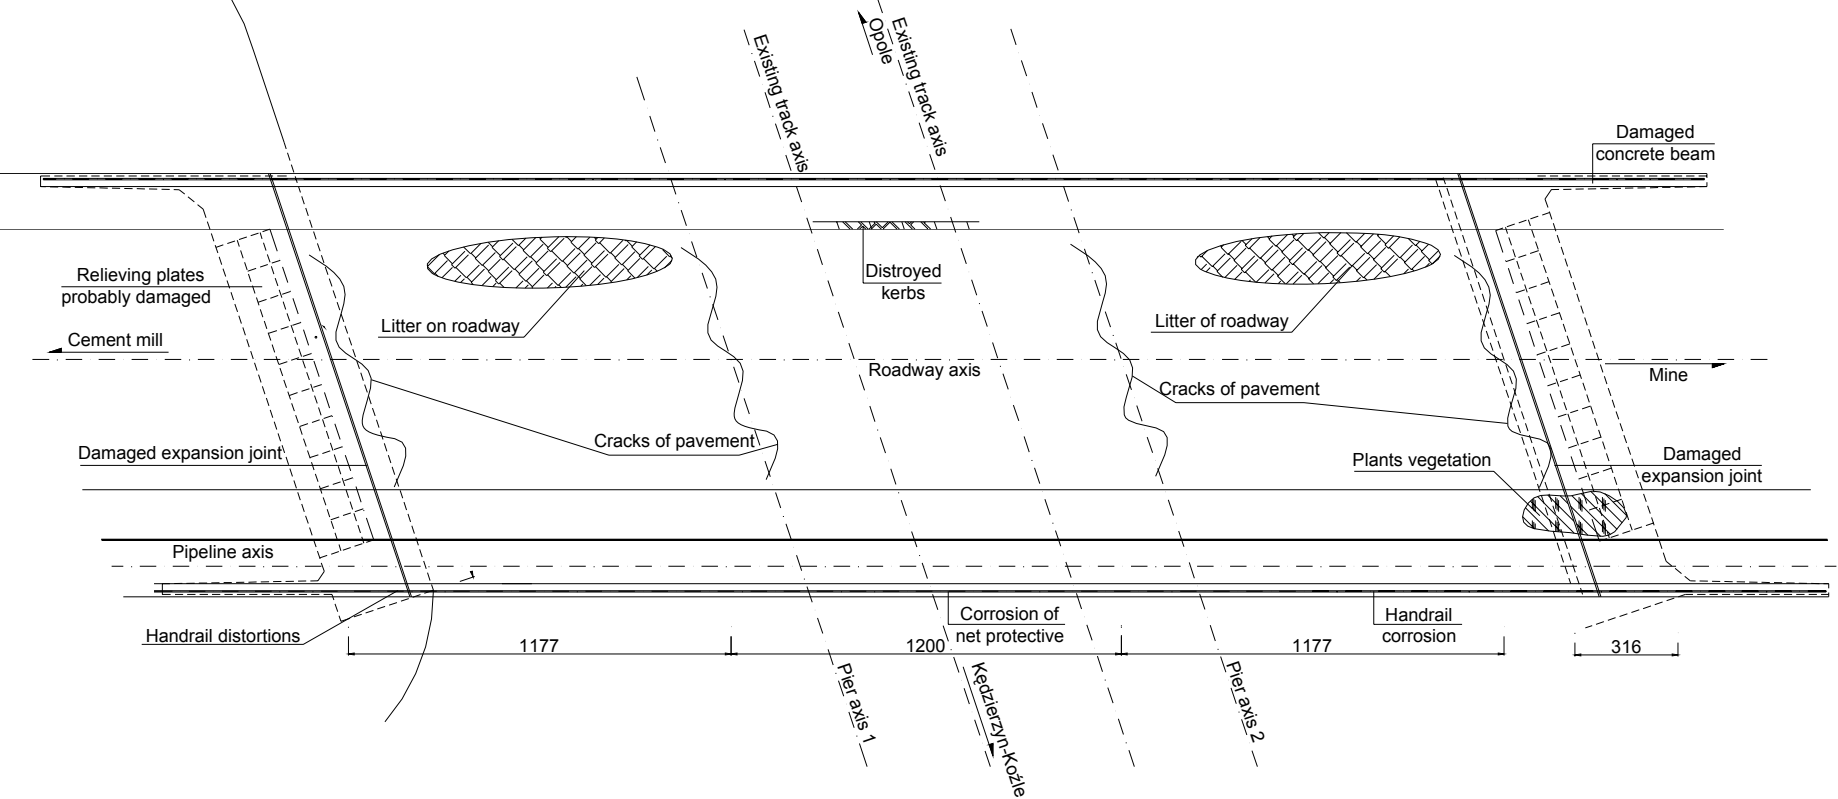
a)

SIDE VIEW

b)

Plan on roadway level

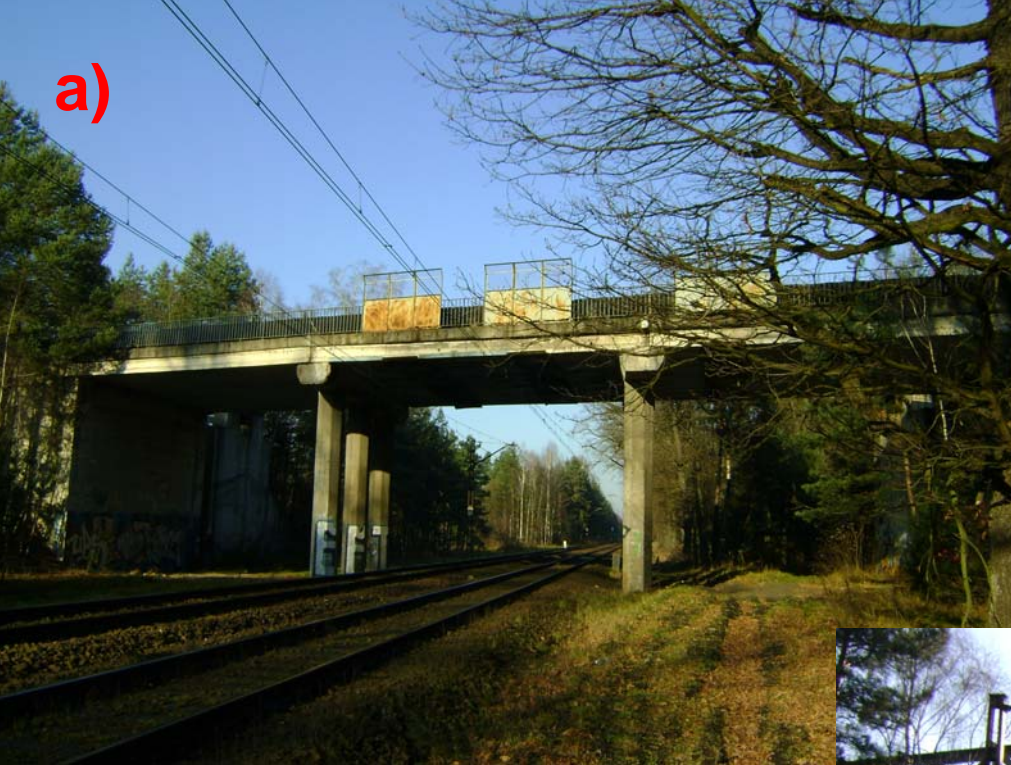
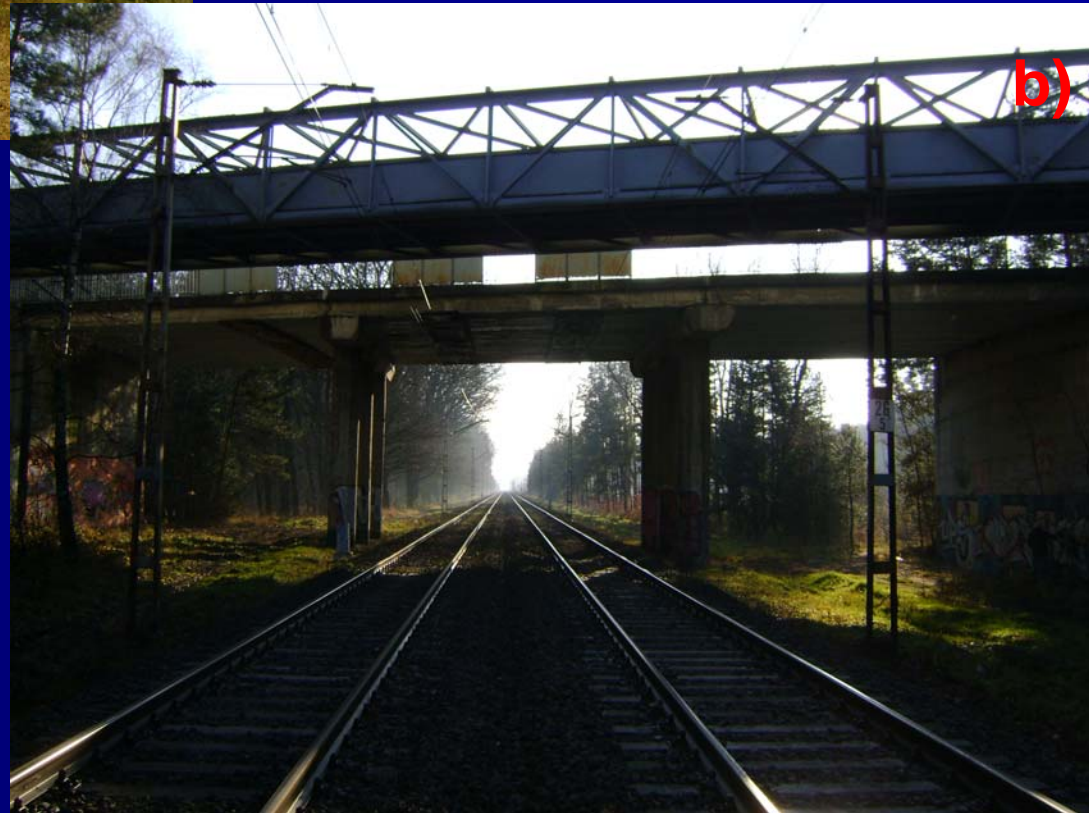
**General side view on the road viaduct: a) from Kedzierzyn Kozle side, b) from Opole side**

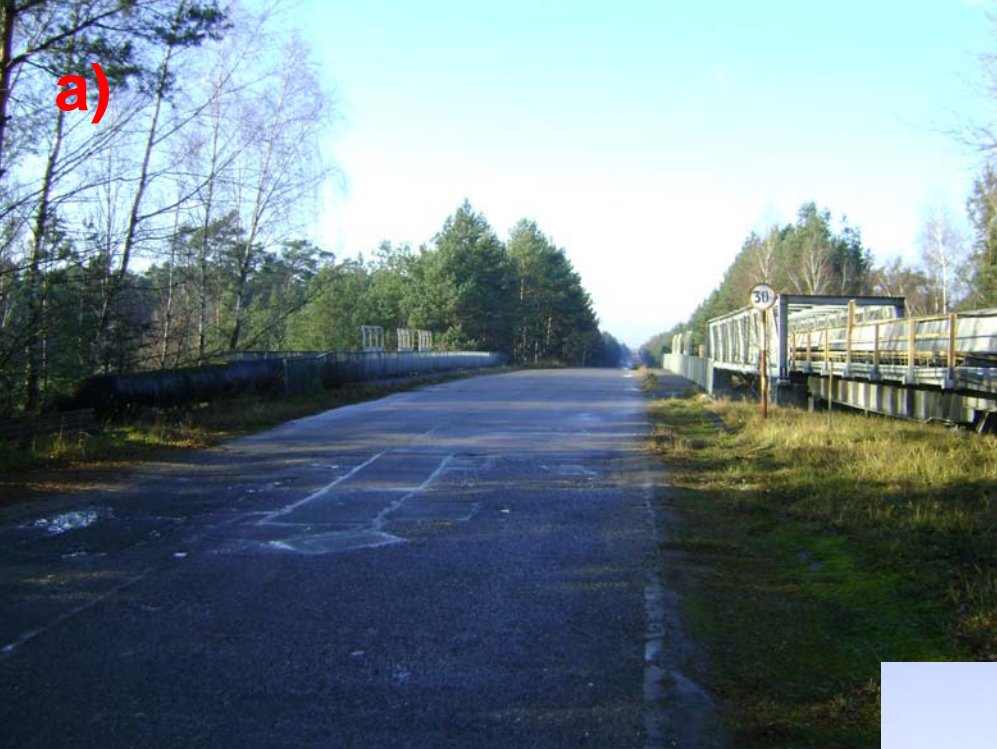
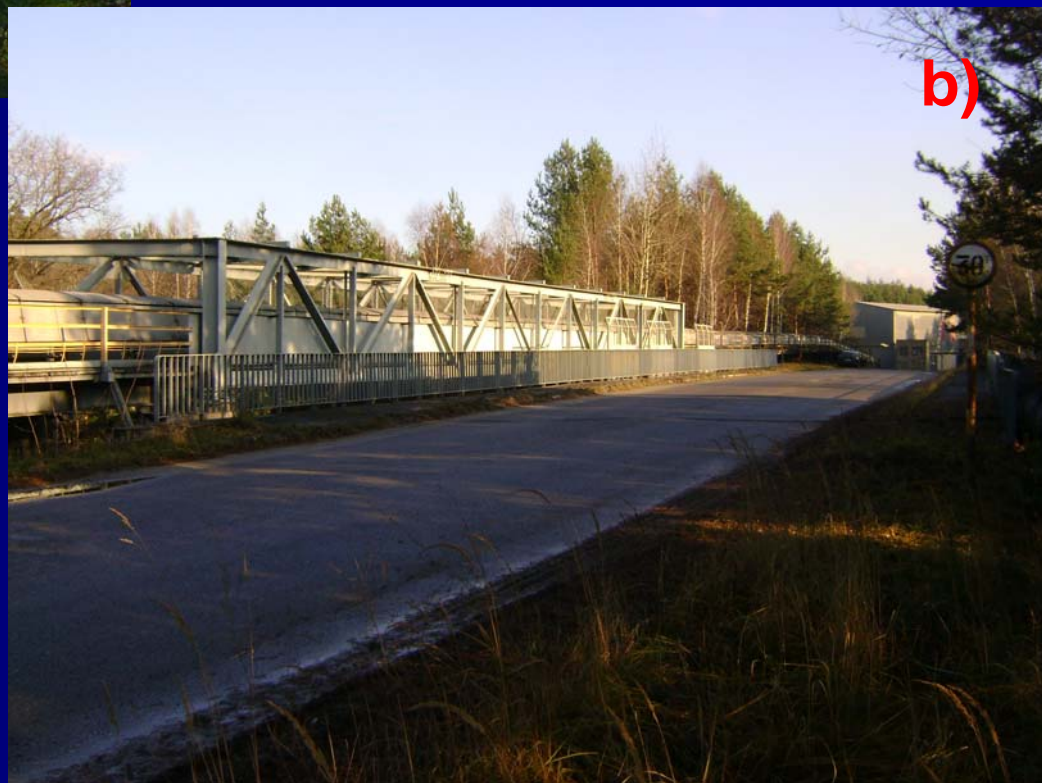
**General view from the road level on road viaduct: a) from the lime stone mine side, b) from the cement mill side**

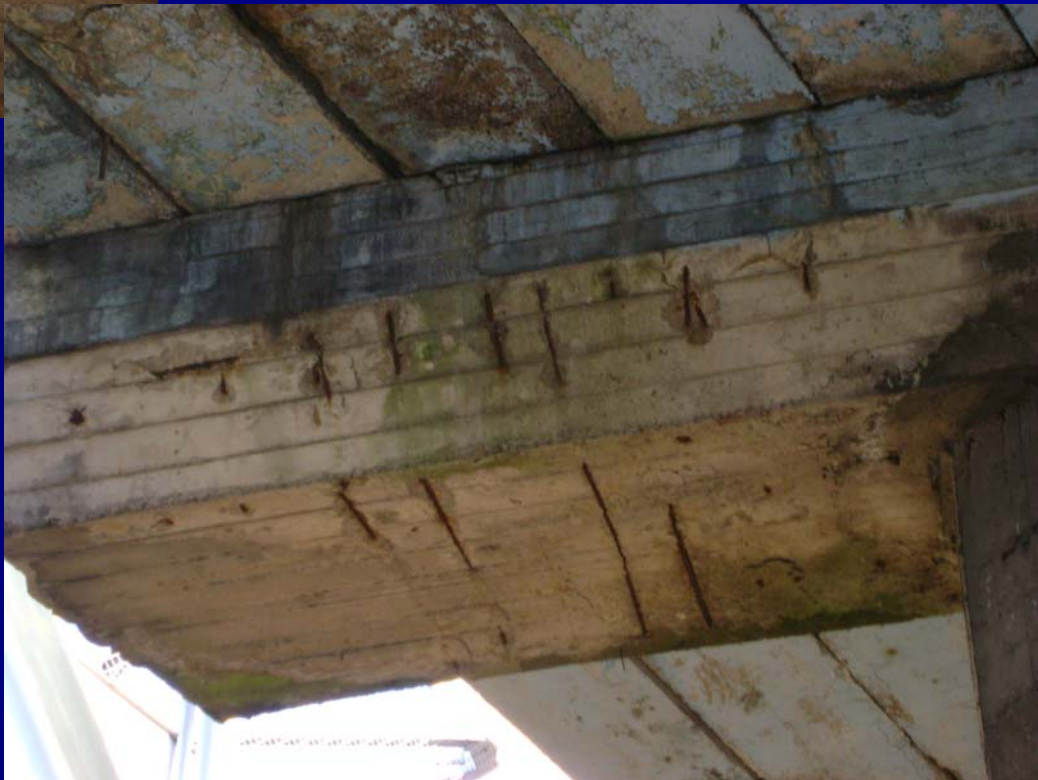
- ❑ a lot of reinforcement lagging lacks of reinforced Gromnik type concrete girders - it was the reason of progressive concrete girders steel reinforcing bars corrosion 1,
- ❑ a lot of damp patches, blooms and icicles from the bottom side of the spans. It provides that insulation of the bridge deck was not tight and non-effectiveness of drainage system 2,
- ❑ concrete corrosion in some main girders (decorticates) 3,

**Bottom view on damages and reinforcement lagging lacks of main girders and piers cap**

- ~~clean~~ and anti-corrosion protect uncovered reinforcing bars,
- complete the reinforcement lagging lacks of reinforcement,
- rebuild of piers cap,
- exchange of expansion joints,
- clean the concrete surfaces from blooms and damp patches,
- clean, complete and execute of cover layers on concrete elements.

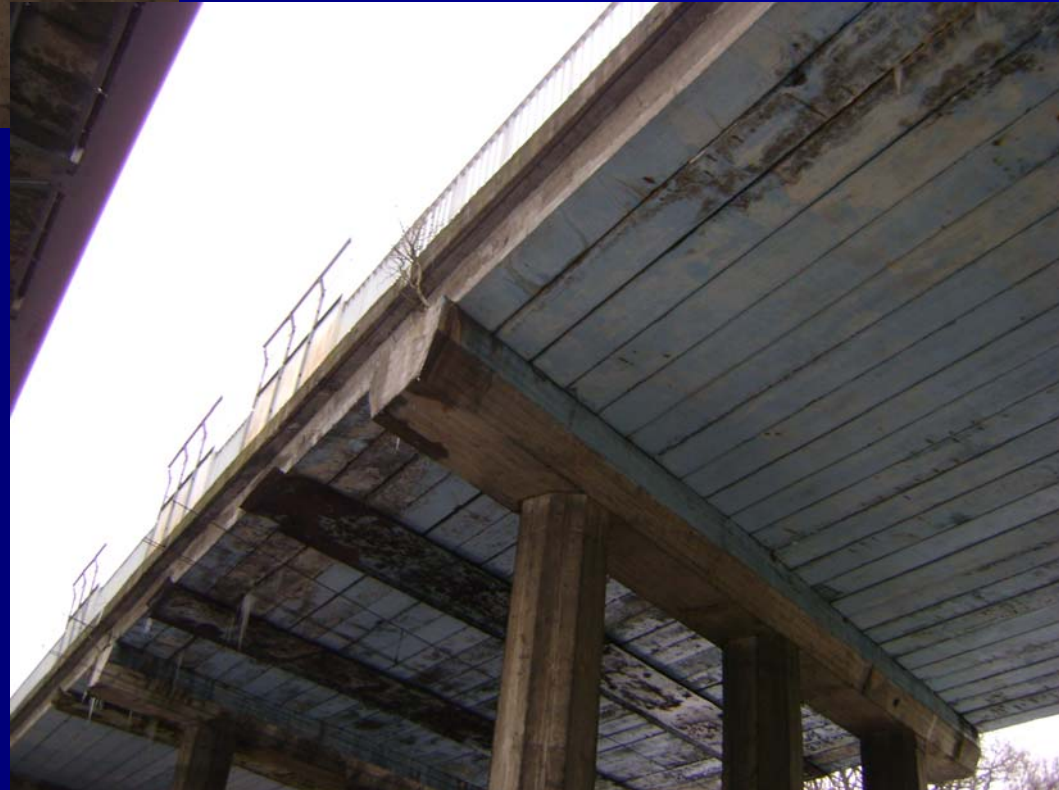
**Bottom span view.  
Visible damages of main  
girders and piers cap  
(concrete corrosion,  
decorticates, damp  
patches).**

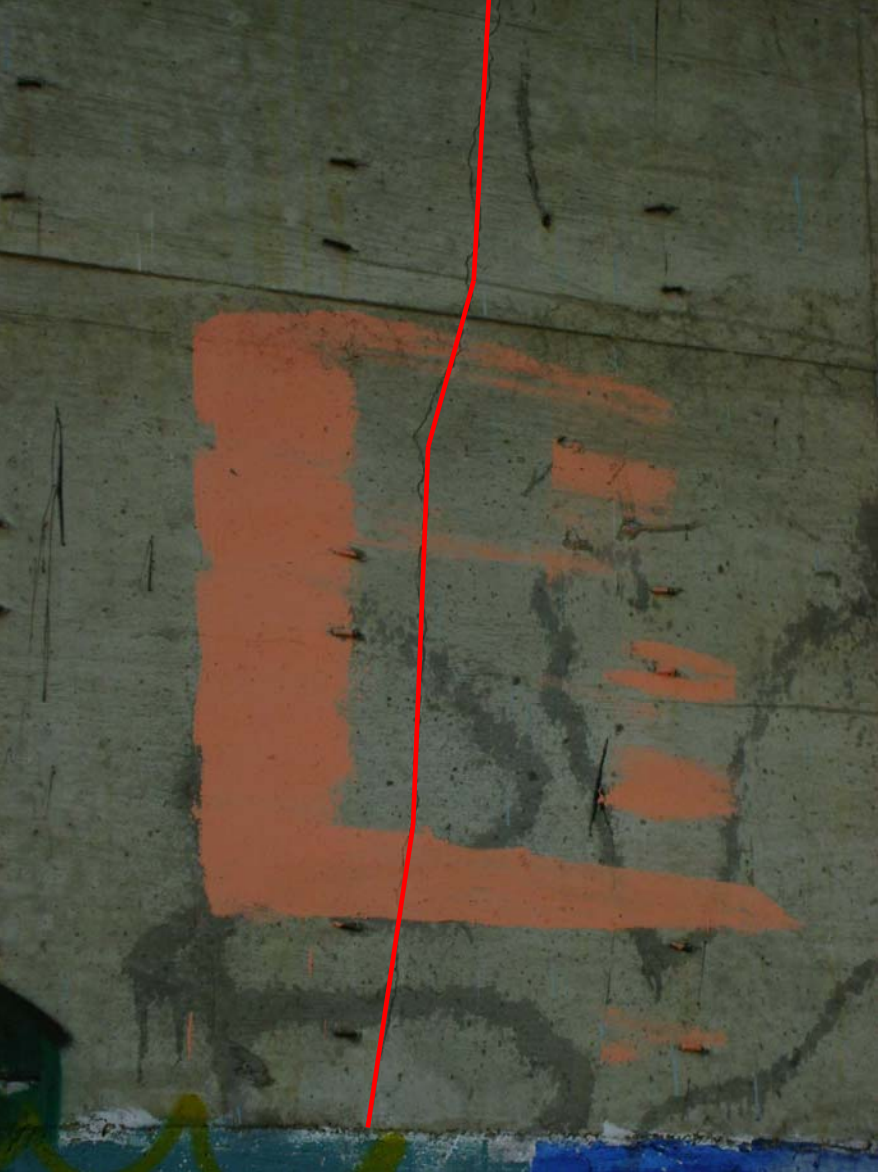
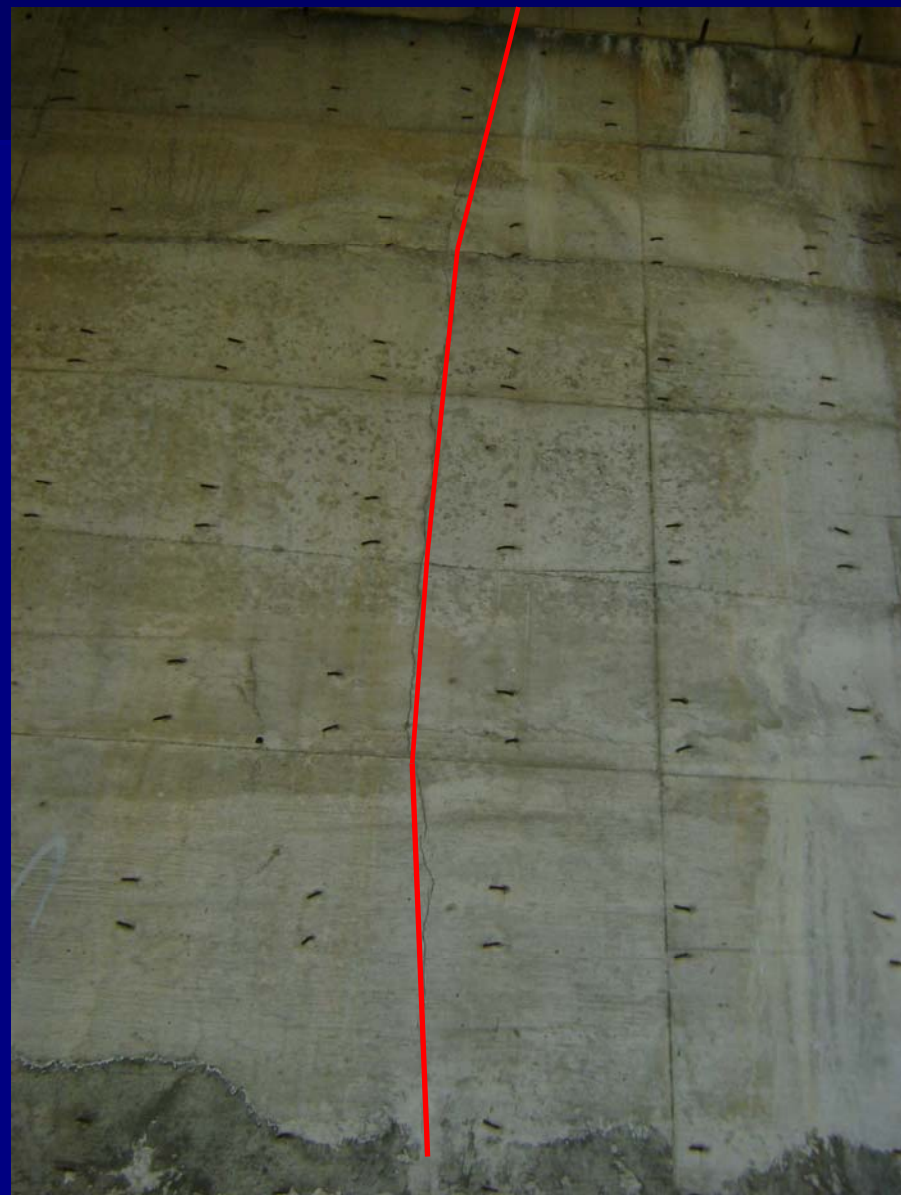
- ❑ 6 cracks thickness less than 1.0–1.5 mm on the left abutment (from the cement mil side). Four of them run across the whole pier height (from bridge deck plate to foundation), what can provide unequal settlement of the pier 6,
- ❑ two cracks, thickness less than 1.0 mm on the right abutment (from the lime stone mine side). One of them run across the whole pier height and additional visible damp patches and vegetation of moss ,
- ❑ visible reinforcement lagging lacks, concrete corrosion of both abutments (decorticates), and corrosion of reinforcing steel bars too 7.

**View on the glass seals glued to the cracked surface of the abutments**

- verify the propagation of the cracks by glass seals gluing 5,
- if the cracks were stabilized it was necessary to inject the cracks by injecting emulsion and complete uncovered reinforcement lagging lacks by suitable PCC mortars,
